Electrical Resistivity Tomography for the detection of subsurface cavities and related hazards caused by underground coal mining in Coahuila

José A. Batista Rodríguez*, Marco A. Pérez Flores, Yuri Almaguer Carmenates and Maximiliano Bautista Hernández

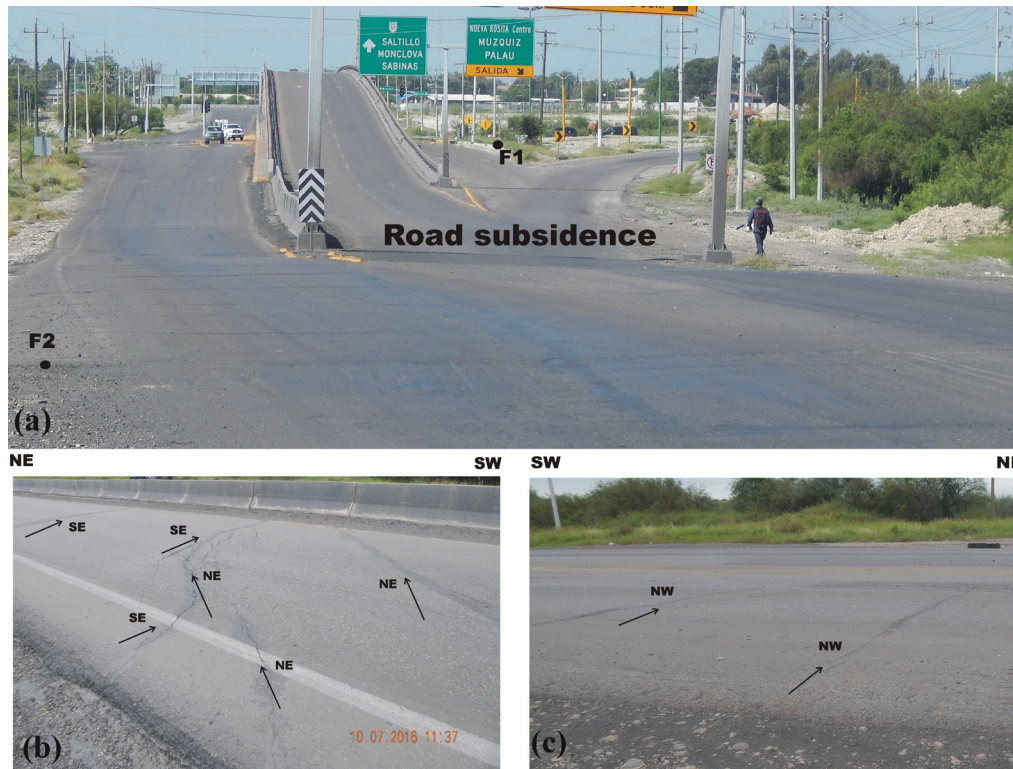
This sector contains both a road and a bridge support (Figure 5), with subsidence found on the road at the northeast end (Figure 9a), which could be related to the underground coal mining (Peng, 2008) due the shallower mining activities in this sector and its surroundings.

The northeastern end of Profile 2 covers the area of the road where subsidence is found (Figure 9a). Two possible cavities are identified with the ERT below the road, at 13 m depth, with both structures presenting different electrical resistivity, size and depth (Figure 10). It can be inferred from the resistivity image that the first cavity is smaller, larger resistivity and partially empty or filled with dry sediments. The second cavity is larger, lower resistivity and filled with either water or water-saturated sediments (Van Schoor, 2002; Zhou *et al.*, 2002; Martínez-López *et al.*, 2007; Putiska *et*

al., 2012). Above these cavities, around 7 m depth, a small size aquifer is located within the Sabinas Conglomerates (CONAGUA, 2015). Above the area that covers both cavities, the road is highly fractured, with some fractures cutting across the entire road (Figures 9b and 9c). The electrical tomography suggests that some of these fractures penetrate into the subsoil, mainly in the area of the second cavity (see the inferred fracture in Figure 10).

Figure 9. Sector 1. a) Image showing the subsidence of the road. b) and c) Image showing fractures on the road surface in profile P2. Arrows indicate location and direction of the fractures. Reference points for the photographs shown in b) and c) are indicated as F1 and F2 in Figure 2, respectively. F1 and F2 also are indicated in Figure 9a.

These results suggest that special attention should be paid to both of these areas and to activate a system for monitoring the roads and the bridge integrity in order to avoid damage due to the gradual or sudden land collapse.

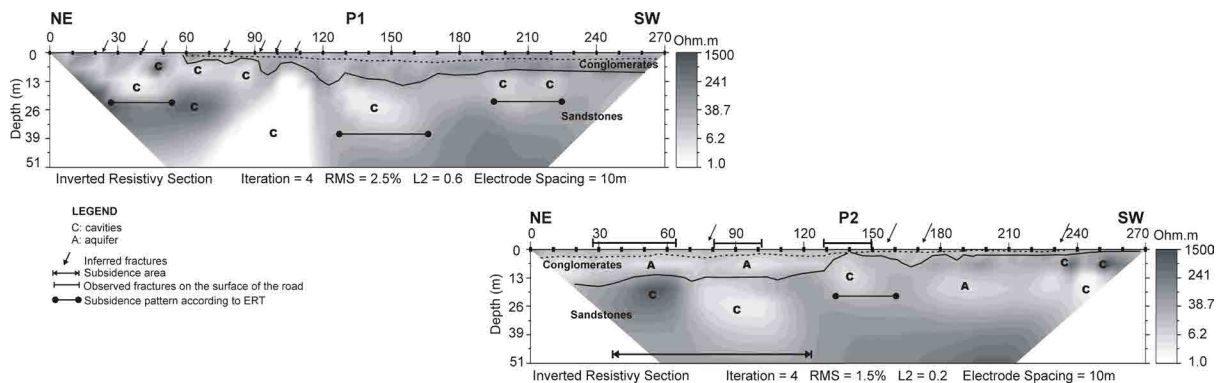
Four small cavities are found in the SW end of Profile 2 (Figure 10), located next to the bridge (Figure 5) with subsidence on the road (Figure 9). Two cavities have very low resistivity, while the other two are more resistive, smaller and shallower (approximately 7 m). The cavity found at the center of the profile is clearly the cause of fracturing on the road surface. Moreover, in this zone, the ERT results show at patterns that suggest subsidence, namely, zones of low resistivity (represented by the light gray color) with a convex form (Figure 10).

Profile 1 also shows several cavities from a depth of 7 m onwards, most of which present low values of resistivity and are small in size. Above these cavities water table of about 5 m inside the conglomerates is located. According to the ERT, the geometry of these structures shows patterns of probable subsidence, although no visible deformations are observed on the surface of the roads. These patterns were found in the ERT results for zones with low resistivity and convex shapes with respect to the surface (Figure 10). These zones resemble the characteristic descent into a small basin which is caused by the accumulation of sediments. Towards the northeast of the profile, a large cavity with very low resistivity was observed, extending from a depth of 10 to 50 m ($x=110$ m). Above this cavity, the road presented no subsidence; however, the ERT showed that it is so close to surface that we expect possible fracturing on surface. We found, in some buildings adjacent to the road fractured walls. All fracture systems observed on the road are perpendicular and oblique to the highway (Figures 9b and 9c), following the probable galleries direction (Peng, 2008). The fracture systems follow three different directions: perpendicular to the road on a NW-SE direction; oblique on a NE-SW direction; and, a NW-SE direction.

Figure 10. ERT of Sector 1 (profiles P1 and P2). The section of P2 from 170 to 270 m is located next to the bridge. Continuous curved lines indicate boundaries between rocks and discontinuous curved lines indicate water table. The profiles are located graphically according to their position in the field (see Figure 5).

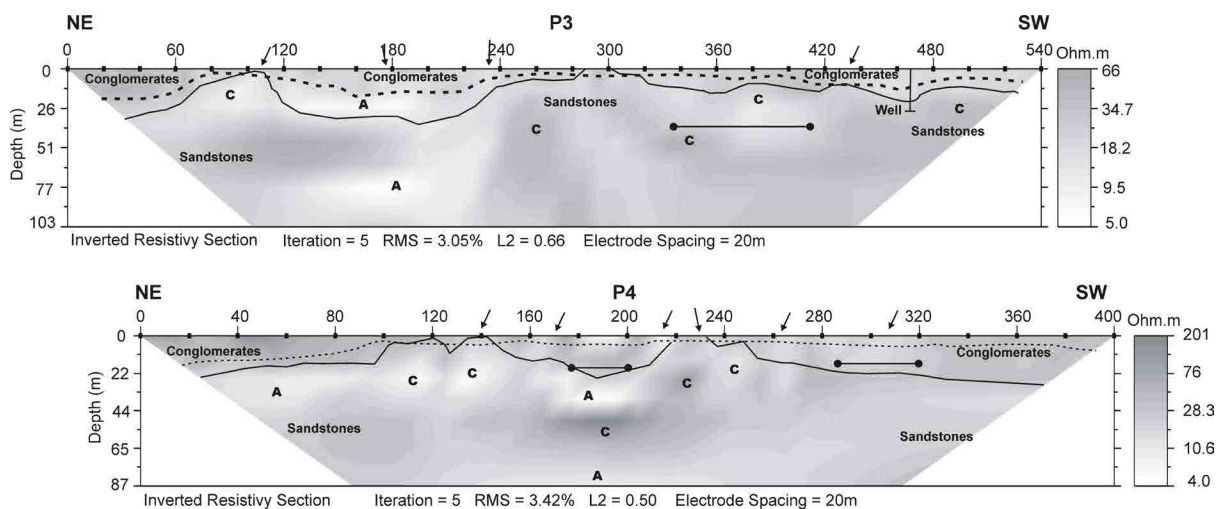
shape and they are located at two depth levels (approximately 22 m and 50 m). Some of these cavities were observed at both sidewalks, indicating that they are connected and cross under the road. All cavities identified are low resistivity (represented by the light gray color). Values lower than 10 ohm-m suggests that the cavity is water-filled (Van Schoor, 2002; Zhou *et al.*, 2002; Martínez-López *et al.*, 2007;

Putiska *et al.*, 2012). This water is provided by the aquifers located in conglomerates and the upper level of the Olmos Fm. (Figure 11). The water table was determined with using a well located in the profile P3 ($x=465$ m) with a water table at 12 m. Their variations are established using resistivity values. Cavities with a resistivity between 30 and 200 ohm-m may be filled with sediments slightly saturated with water (represented by the light gray color; Van Schoor, 2002; Zhou *et al.*, 2002; Martínez-López *et al.*, 2007; Putiska *et al.*, 2012), probably due to cavity collapse. It is possible that some faults or fractures infiltrated water inside the cavities as a first stage and the absence of water as a second stage could cause the collapse itself.

The larger cavities (30 m wide and 25 to 35 m high) identified at a depth larger than 30 m, do not produce visible road deformation; however, this is not a general rule. Some of the zones with probable land subsidence ($x=360$ m in P3 and $x=180$ m in P4) are related to cavities deeper than the mentioned depth.

It should be noted that, most of the cavities identified are located on both sides of the bridge support. The bridge support itself is located in an area with a large hazard level.

Figure 11. ERT of Sector 1 (P3 and P4). The profiles are located graphically according to their position in the field (see Figure 5). Continuous curved lines indicate boundaries between rocks and discontinuous curved lines indicate water table. The section of P3 from 0 to 280 m and the section of P4 from 0 to 230 m are located next to the bridge. Vertical line indicate well.

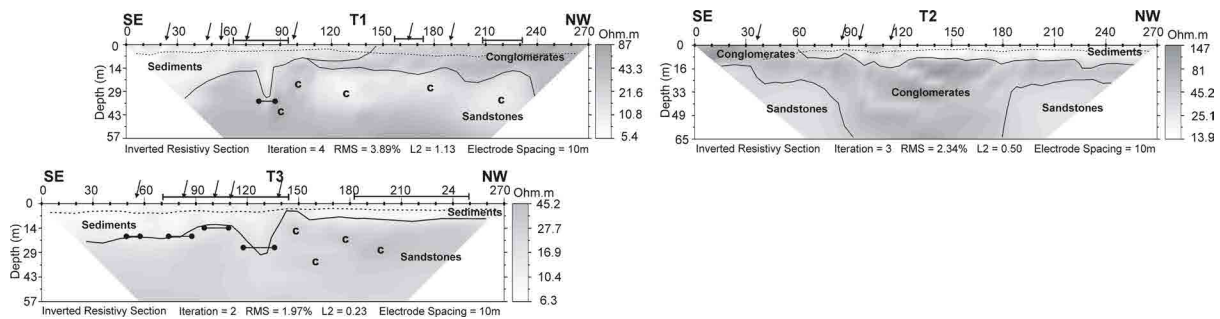
Sediments with a very low resistivity outcrop at the SE end of T1 and they extend to depths larger than 35 m (Figure 12). Electrical resistivity values suggest that these sediments are water saturated, in which the water table oscillates around 5 m, deepening to the NW of the profile T1, according to the resistivity values. Towards the SW end of the profile, conglomerates outcrop and extending to 14 m depth. Several cavities, beginning at a depth of 14 m, are identified in the sandstones underlying the sediments and conglomerates, all of which recorded low resistivity values (Figure 12), indicating that these structures are probably filled with water or water-saturated sediments.

This study identified several fracture systems on the road above the identified cavities (Figure 12), with most of these fractures running perpendicular to the road (Figures

Figure 12. ERT of Sector 2. The profiles are located graphically according to their position in the field (see Figure 6). Continuous curved lines indicate boundaries between rocks and discontinuous curved lines indicate water table.

Sediments and conglomerates outcrop in the T1 and T2 models (Figure 12), while ten meters depth, conglomerates cover almost the entire Profile 2 (T2) and raise a thickness of 50 m at the center. No cavities in the central part are identified in the ERT model. This explains why no fractures were found on the road.

Profile 3 (T3) is located on the opposite sidewalk (Figure 12). Only sediments outcrop in Profile 3 and the cavities identified in Profile 1 also appear, suggesting that they are located below the road.

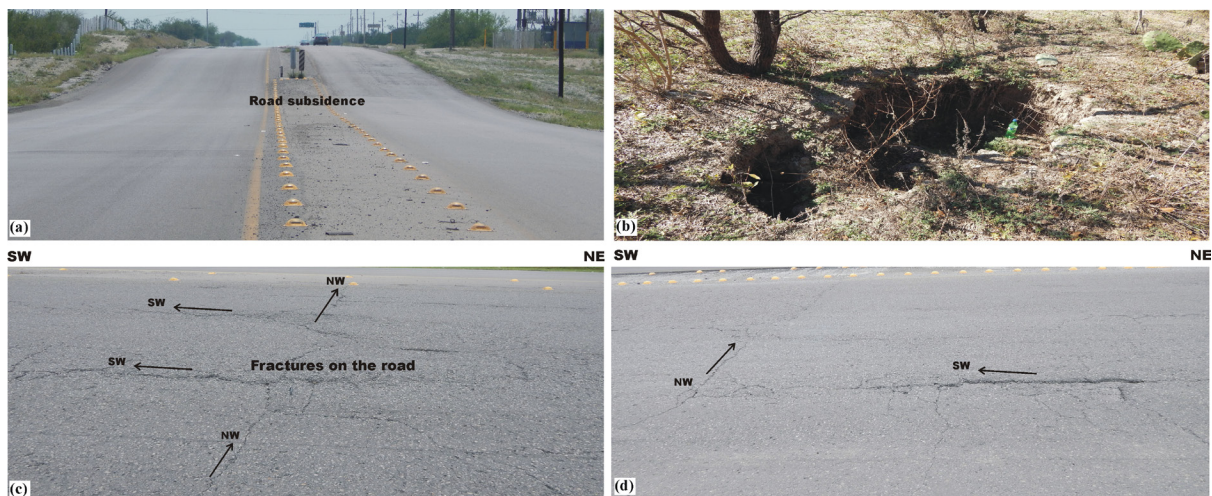
This sector includes a road which is located next to an abandoned underground coal mine (Mine 4 in Figure 7), which reached an approximate depth of 350 m. Two sections of extensive subsidence were identified on the road (Figure 14a), related, apparently, to underground mining.

findings indicate a high level of fracturing at depth, which was also identified on the road surface (Figures 14c and 14d). The two zones presenting subsidence on the road surface are located at $x=200$ m and $x=860$ m in G2.

The subsidence patterns observed in Sector 3 are different from those found in sectors 1 and 2, in that, in Sector 3, the subsidence on the road surface occurs between two identified cavities rather than above them, as found in sectors 1 and 2. According to the ERT models generated for Section 3, the sinking seems to be related to the deepening of the aquifer level between two cavities. The cavities observed in Sector 3 are generally larger and deeper. Therefore, it is assumed that the fracture systems and subsidence patterns are related to the change in the hydrodynamic groundwater regime, probably caused by the water flow toward the underground galleries which is generated by deeper-level underground mining activities (occurring after 350 m). Once the underground cavities have been created, the underground water inside them is displaced, deepening the phreatic level. The conglomerates undergo a compaction process over time, leading to subsidence. At the NE end of Sector 3 (Figure 7), several sinkholes are observed (Figure 14b), indicating the existence of underground cavities generated by mining.

Figure 14. Sector 3. a) Image showing the subsidence of the road. b) Image of a sinkhole next to the road. c) and d) Images of fractures on the road surface in Profile P1. Reference points for the photographs shown in c) and d) are indicated as F1 and F2 in Figure 7, respectively.

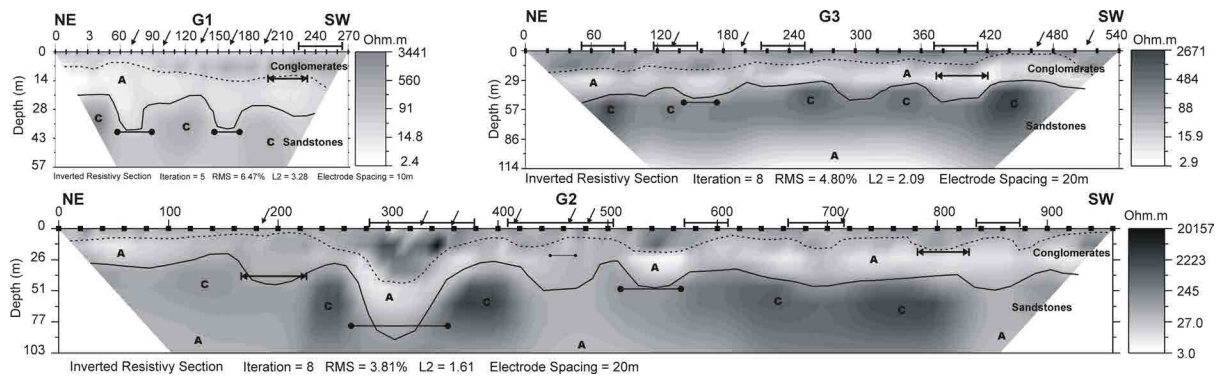
data continuity and, therefore, a 960 m-long continuous resistivity model. Several cavities were also identified in these profiles, most of them larger and deeper than those identified in the previously described sectors (Figure 15). Generally, cavities were identified at a depth of 30 m and reached up to 50 m in diameter.

Figure 15 shows that, generally, the aquifer level becomes deeper in the zones between the cavities ($x=60$ m, $x=150$ m and $x=200$ m in G1; $x=200$ m, $x=290$ m and $x=440$ m in G2; and, $x=300$ m in G3). Two of these zones are located just below the subsidence observed on the road (Figure 14a). One zone is located at the SW of G1 and another at around $x=200$ m in G2, while a third is found at around $x=800$ m at the SW end of G2 and at 380 m in G3 (Figure 15). In all the zones located between the cavities identified in this study, a high number of fractures were observed on the road (Figures 14b and 15).

Within the sandstones, another aquifer was found at a depth of 100 m below the cavities (Figure 15), in some areas connected to the upper aquifer located at $x=200$ m, $x=460$ m, and $x=860$ m in G2. This finding concurs with the CONAGUA (2015) results, which indicate the connection, through fractures, between the shallow and deep aquifers. These ERT

Most of the cavities identified in this study present high values of electrical resistivity, indicating that they are not water-filled and, instead air-filled or partially filled with sedimentary materials (Martínez-López *et al.*, 2007; Putiska *et al.*, 2012). These materials may be associated with the ceiling collapses that have occurred in the mining structures.

Figure 15. ERT of Sector 3. The profiles are located graphically according to their position in the field (see Figure 7). Continuous curved lines indicate boundaries between rocks and discontinuous curved lines indicate water table.
