# Neotectonic related geological risk at dams in the Mexico Basin: Guadalupe dam

Salvador Marín-Córdova<sup>1</sup>, Oscar Campos-Enríquez<sup>2</sup> and Mario Herrera-Moro-Castillo<sup>3</sup>

## ABSTRACT

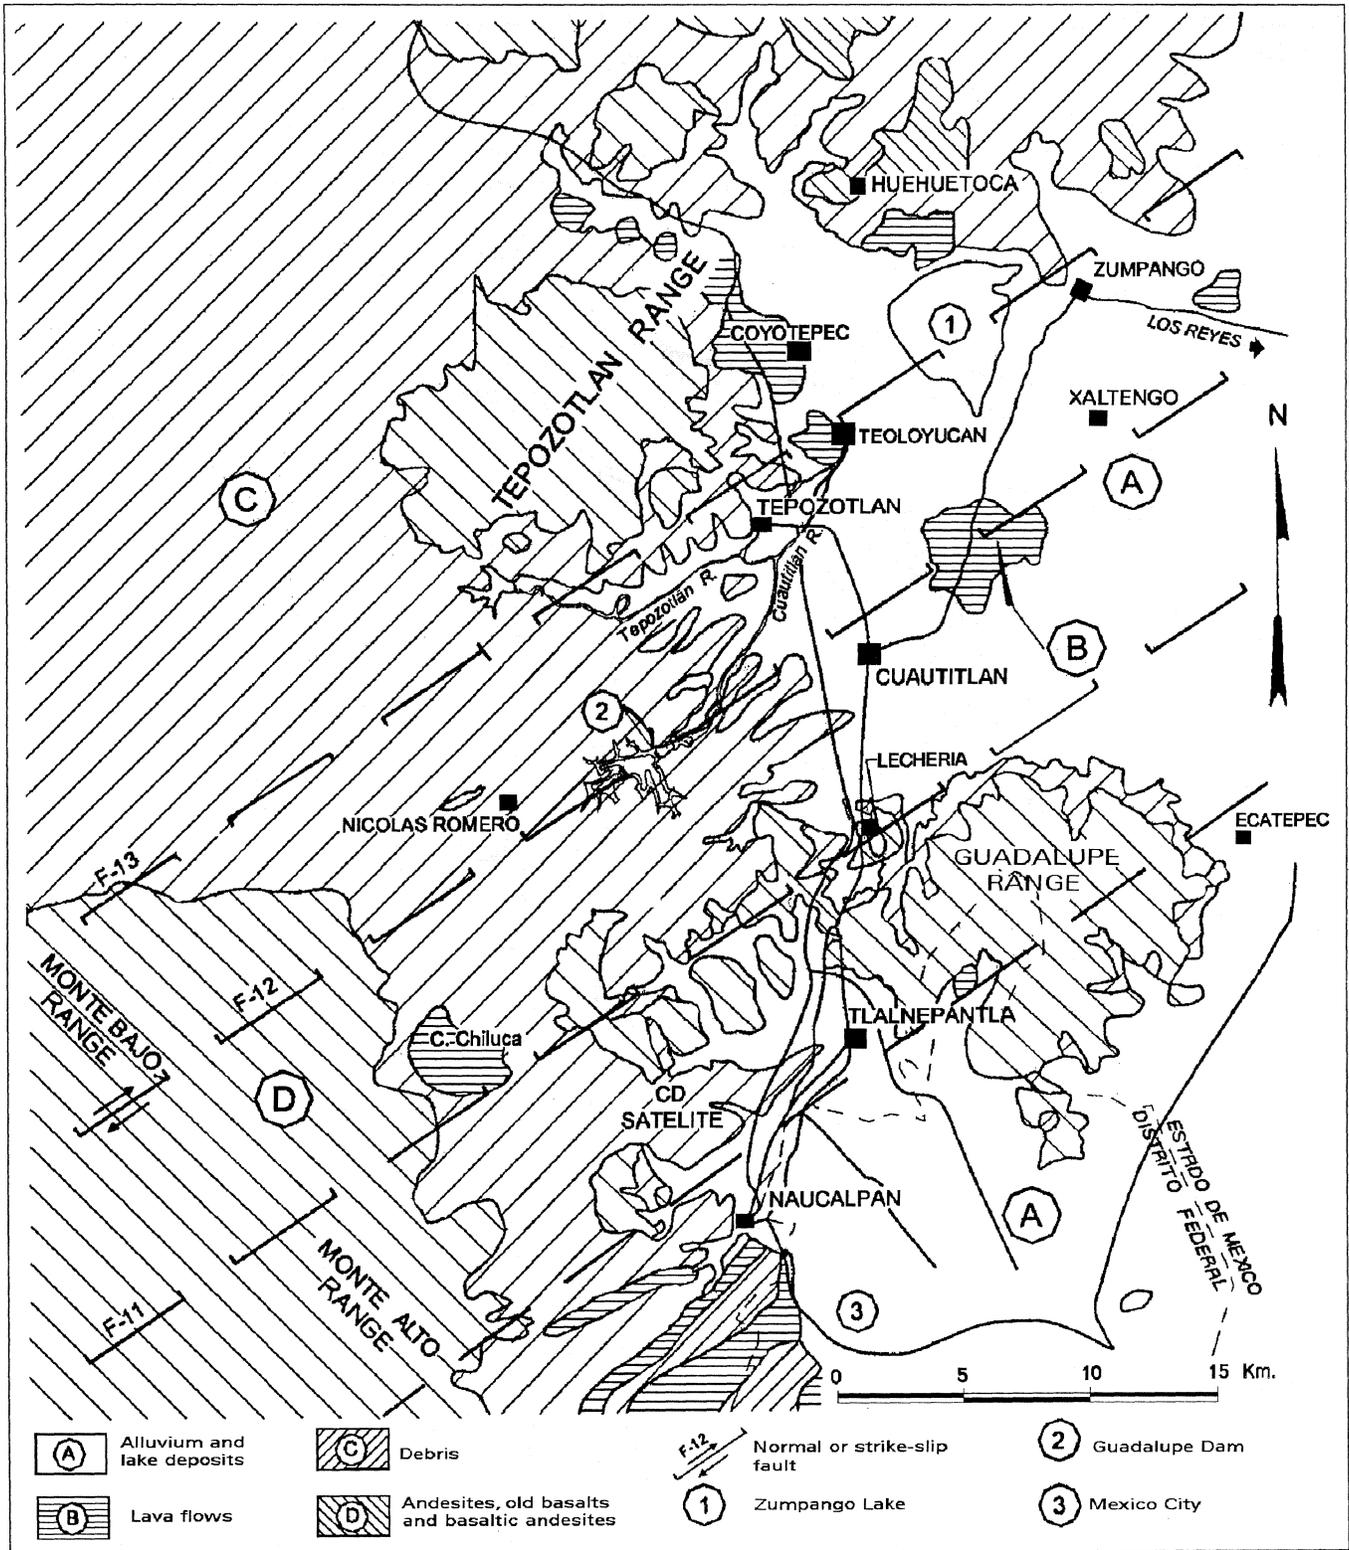
Fig. 3. Geological map.

Figure 3 presents the simplified geology of the area. The volcanic units and alluvial and lacustrine outcrops are Tertiary and Quaternary.

The dam foundation rests on heterogeneous deltaic alluvial deposits, in a valley probably drained by an ancient river bed. Because of this setting differential settlements caused effective tensional stresses in the structure. Several SSW - NNE and WNW - ESE, fractures affecting the Tertiary units have been documented (Alberro *et al.*, op.cit.).

This geological anomaly may correspond to the trace of the F-12 fault, as shown in Figure 3 which, according to the definition of Slemmons and McKinney, (1977), may be considered an active fault.

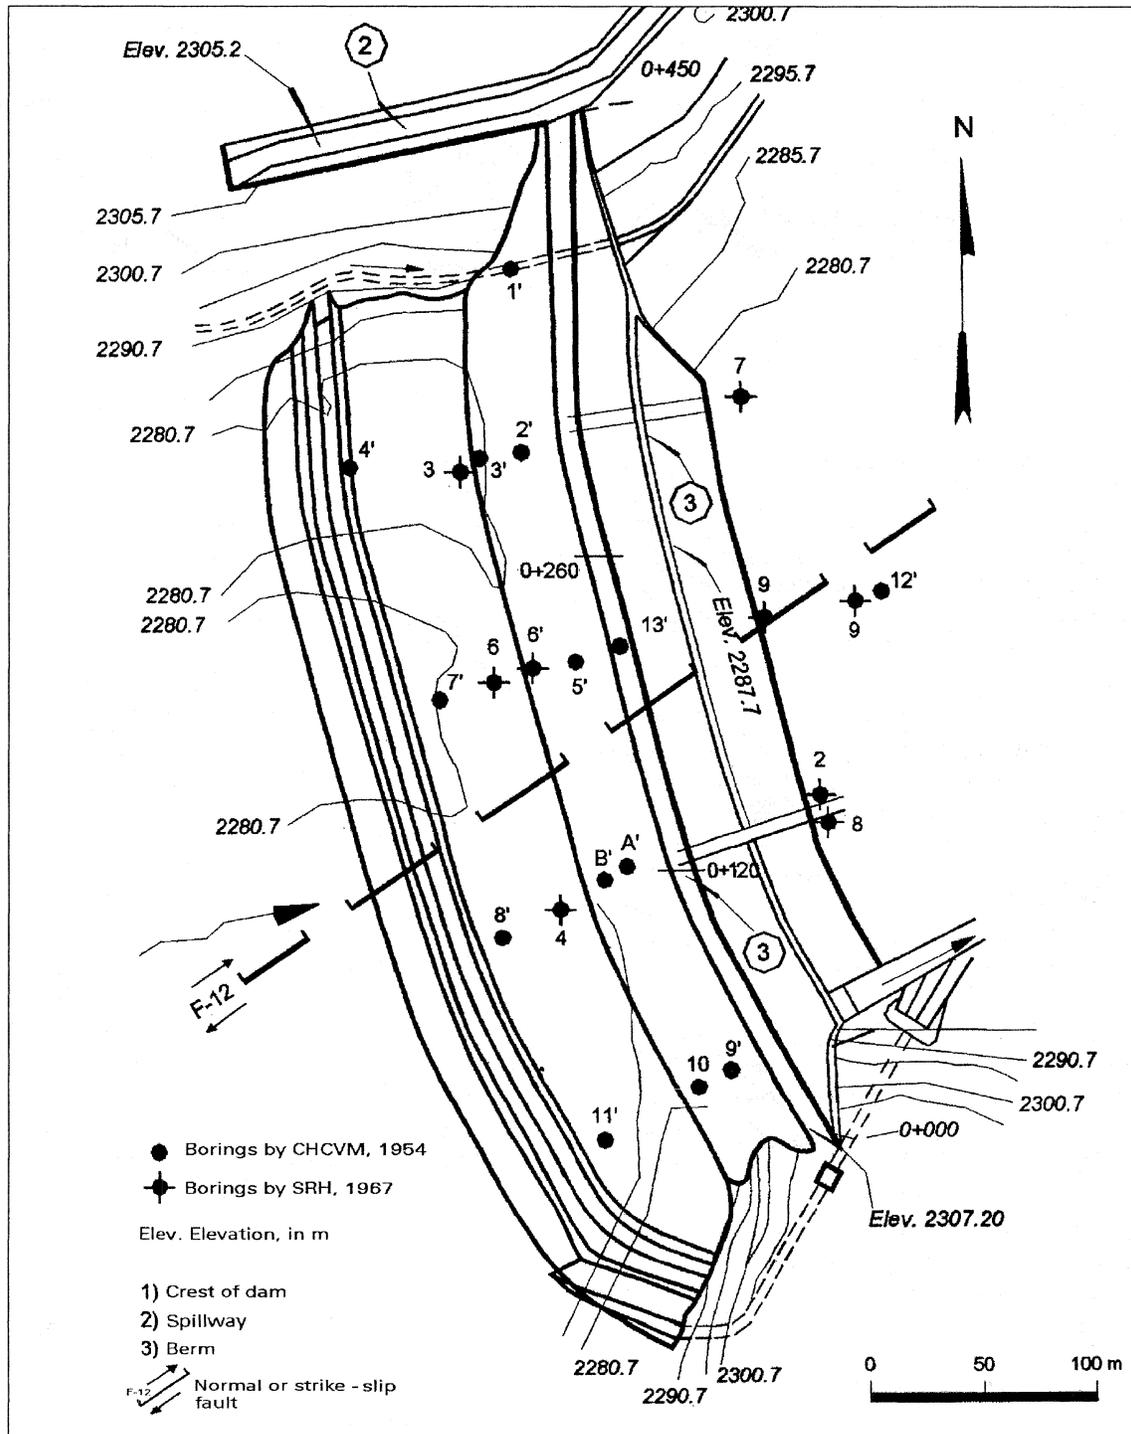
Fig. 4. Boring location and transtentional fault at Guadalupe dam, after Marín Córdova *et al.* (1986 b).

Alberro *et al.* (op.cit.), concluded that, after the construction, the core and the downstream back of the dam, at the station 0 + 150 underwent settlement and were displaced

towards a zone of the foundation that coincides with the zone of thicker sediment carried. The embankment and the trench upstream from the cut-off were displaced upstream.

Alberro *et al.* (op. cit.) reported that the NNE - SSW axis of maximum thickness seems to be oblique to the axis of the dam and parallel to the tectonic fractures within the

After repair (1948), there were a longitudinal cracks, reported in 1952, and a 2 x 3 x 5 m cavity. Later, revision undertaken at the 0 + 120 and 0 + 260 stations reported cracks transversal to the dam axis.

Based on the behavior of Guadalupe Dam and its relation to the geological-structural frame of the Mexico Basin, we note the effects originated by its emplacement on granular materials, with a coincidence between the direction of the cracks of the dam and that of the F – 12 strike-slip fault.
