# Integration of electrical resistivity tomography with electromagnetic and soil radon measurements for characterizing the leakage problem in Afamia B dam, Syria

Walid Al-Fares and Mohamed Al-Hilal\*

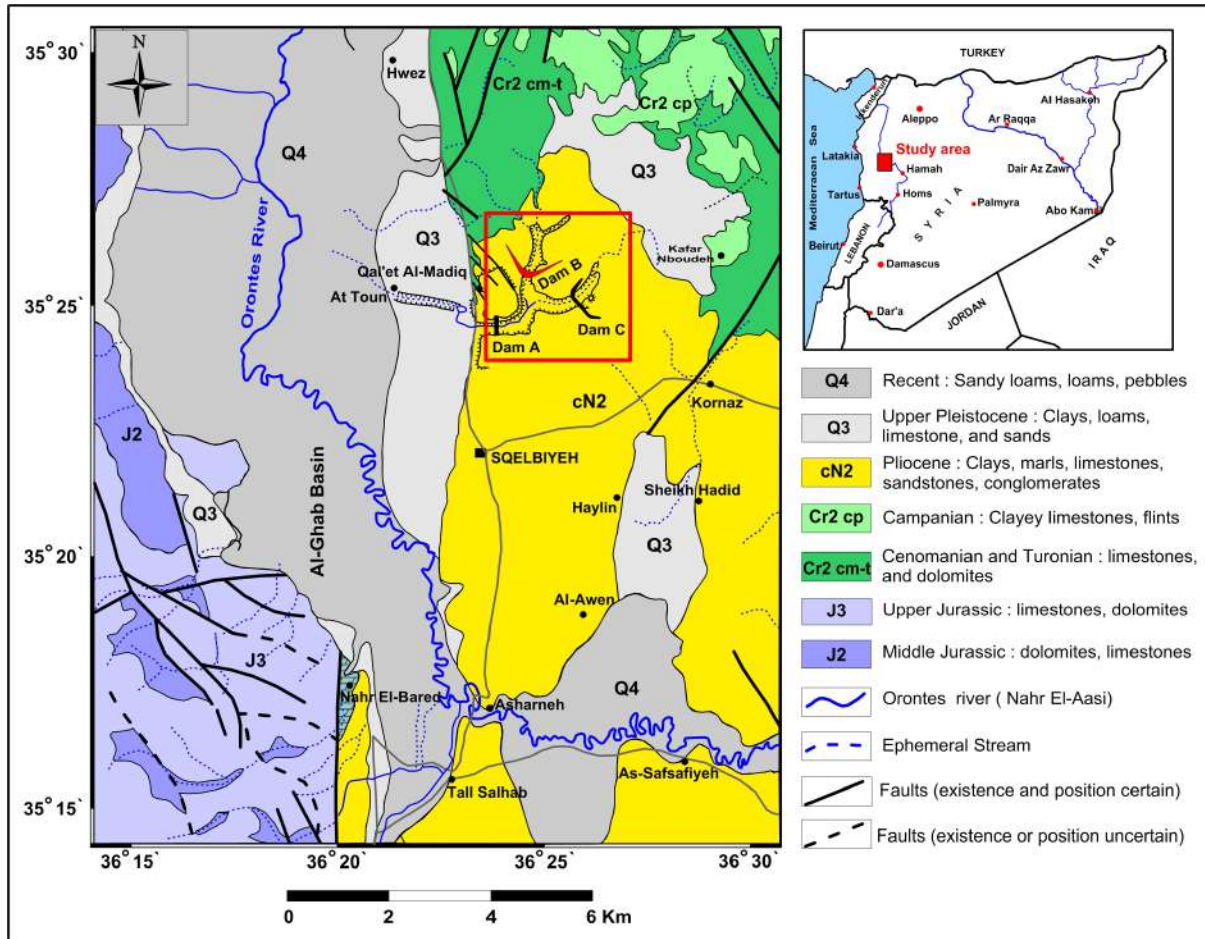
Figure 1. Simplified geological map of the study area showing the locations of Afamia dams (modified after Ponikarov, 1966).

Afamia dams are located on the eastern margin of the Ghab plain in the northwestern part of Syria, close to Qalet Al-Madiq town (Figure 1). The Ghab plain constitutes a prominent fertile terrain in western Syria that suitable for growing a wide range of agricultural activities. Hence, three adjacent earth-filled dams, (A, B and C), were constructed nearby the great ancient city of Afamia, at about 3 km eastern margin of the Ghab basin. In fact, the Afamia dams were built in this area essentially to divert some water out of the Orontes River (Nahr El-Aasi) to be stored and used afterward for irrigation and other domestic uses during drier months of late summer and autumn. The dam B, which has the maximum storage capacity of 37 millions cubic meters, is subjected to serious problems of leakage through the bedrock of its reservoir. It is worth to mention that the dam body extends along 2870m, with 55m high and it has a constant elevation of 282m above sea level (a.s.l.). In 1999, the dam was set in operation and filled up with water for the first time in order to check its validity for water storage. However, the water level in the lake has shown a clear sign of water loss ranged between 17 and 20 cm per day. Therefore, several geological and geophysical investigations, including vertical electrical soundings (VES) and electrical profiling (EP) surveys, have been carried out in dam by the Syrian General Company of Hydraulic Studies (2001). The objective of their surveys was to characterize the geological and tectonic settings of the dam site. Additionally, some foreign consulting companies performed more hydrogeological and geophysical investigations (Minasian, 2001). The results of these studies revealed various anomalies which indicate some probable scattered zones of infiltration distributed in many parts of the dam lake, but the exact pathways of leakage were not defined precisely. Further assessments of the pervious works were fulfilled by a Swiss company in attempt to identify the problem and to better understand the origin of water leakage (Joos and Bussard, 2004).

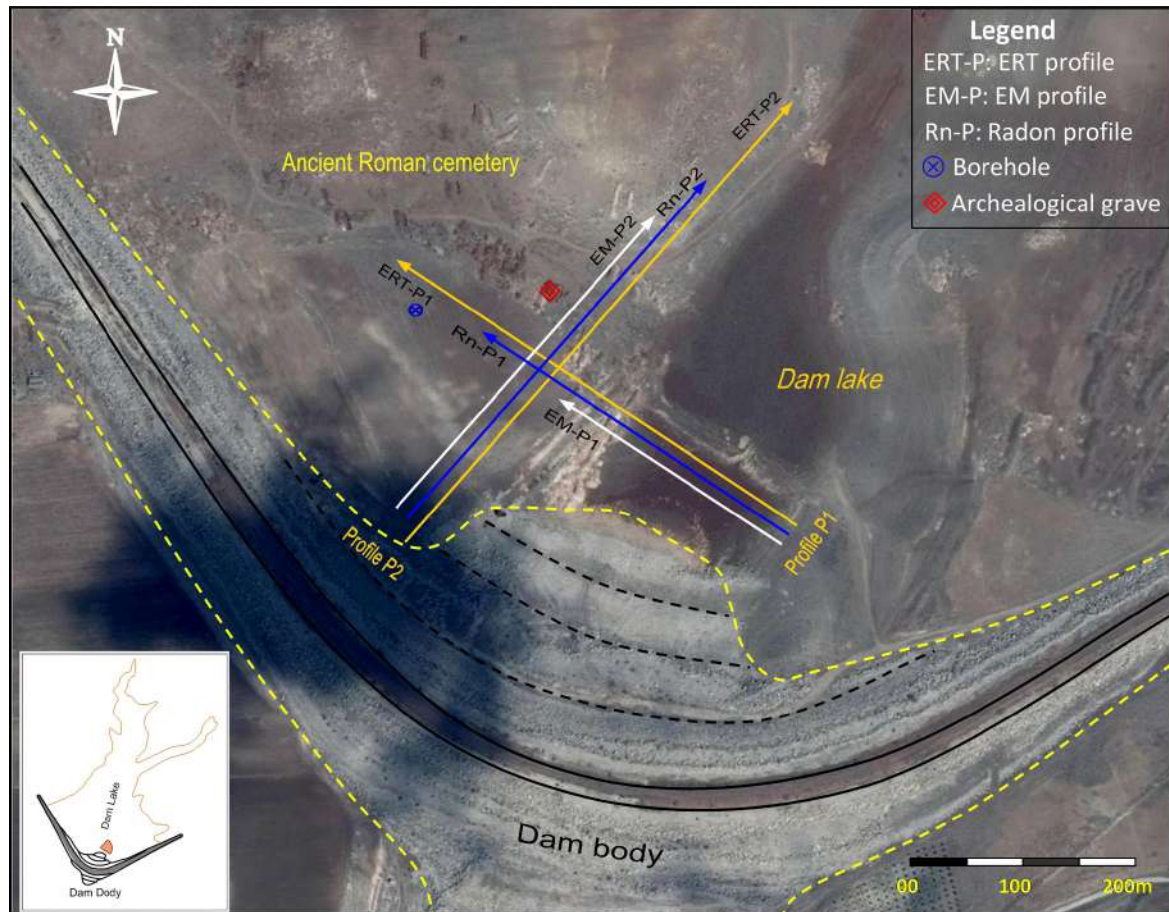
**Figure 2.** Locations of the ERT, EM and soil radon measurement profiles carried out in the lake of Afamia B dam.

In the framework of this study, two main profiles (ERT-P1 and ERT-P2) were chosen in the lake close to the dam body (Figure 2). The first one is extending close to the central part of the dam body and it is perpendicular to the main valley, while the second is stretching along

the included methods carried out along two intersected measuring profiles, denoted as P1 and P2, traversing the main basin of the Afamia dam lake as shown in figure (2). The following sections include detailed discussion and interpretation of the results obtained along both measuring profiles.

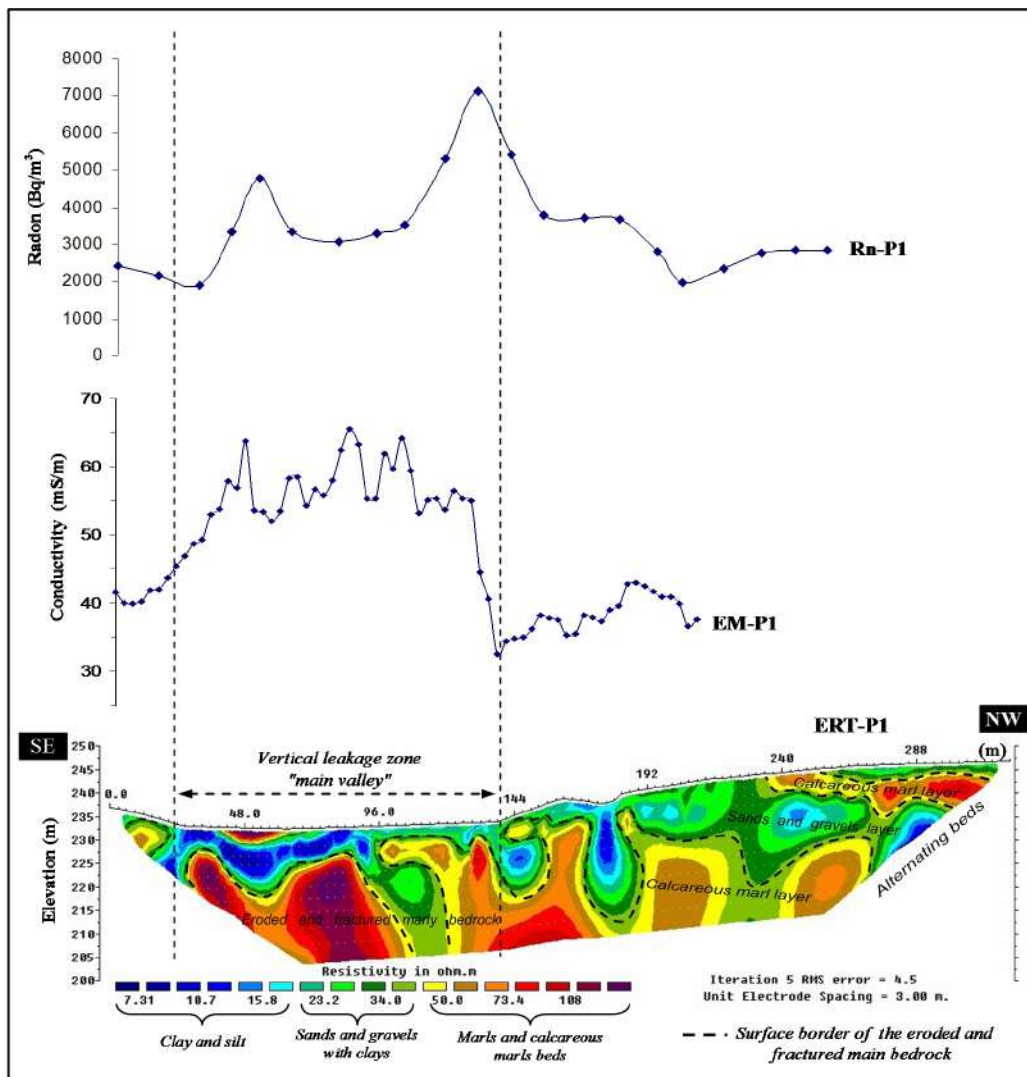
The figure (3) shows the interpretation of the P1 profile, which includes the combination of the ERT-P1, EM-P1 and Rn-P1 measurements. The geoelectrical ERT section reveals the presence of thick clay and alluvial deposits layer covering most of the main valley which extends along a distance of 144m. The thickness of these deposits reaches up and

more than 10m in some parties. In the middle of the main valley (X= 96m of the ERT section), the alluvial deposits extend downward towards the deeper formations. The extension of the alluvial deposits, in this form, could be resulted by the effect of the leakage of water laden with sediments towards the underline eroded layers (Figure 3). The resistivity values of these deposits seems to be relatively low and vary between 7-20 Ω.m. These deposits lay over eroded and fractured bedrock which is consisted essentially of marls and calcareous marls. The resistivity values of this bedrock are ranging between 50 and 120Ω.m with a thickness could reach more than 20m depending to the applied configuration and the used electrodes spacing step (Wilkinson *et al.*, 2006; Szalai *et al.*, 2013).

**Figure 3.** Interpretation of the P1 profile which includes the ERT, EM and soil radon measurements that carried out in Afamia B dam.

In principle, the marly and calcareous marly bed is supposed to be compact and impermeable, but the erosion and tectonic activities deformed its natural feature. It is evident that, the erosion and deformation processes applied on the marly and calcareous bedrock made it permeable and enhance the water to be leached towards the deeper formations. Moreover, the edges of the main valley seem to be associated with local tectonic features, which eventually led to the formation of the present valley in the site. The margins of the valley as well as the irregularity of the marly bedrock surface, which are effectively eroded and deformed, appear to be the principle causative of the vertical leakage in the dam lake. Moreover, the geoelectrical ERT section reveals also a clear alternating lithological succession between sands, gravels and clay layers alternating with marls and calcareous marls beds (Figure 3). The heterogeneity of these beds contributes in certain way by the occurrence of sub-horizontal water leakage through the permeable formations (sandy and gravels sediments) especially when the water storage level begins increasing in the lake. This kind of leakage is almost transformed afterwards to a vertical leakage through the eroded and fractured zones. The alternating bedding, which has been revealed by the ERT section, is confirmed through the comparison with real information of a borehole lithological column drilled close to the dam body (Figure 2 and Figure 4).

With respect to the curve of the EM conductivity (Figure 3), it seems to be well correlated with the inverted ERT-P1 section. The high electrical conductivity values are related with the clay deposits that accumulate within the course of the main valley, where the values reach  $70\text{mS/m}$  ( $\approx 14\Omega\cdot\text{m}$ ). However, a sudden decrease of the EM curve appeared to be well corresponded with the margins of the main valley. This decrease could be due to lithological changes between clay deposits from one hand and sands and gravels from other hand, where the conductivity values decrease to reach less than  $30\text{ mS/m}$  ( $\approx 33\ \Omega\cdot\text{m}$ ).

Concerning the radon concentration along the measuring profile (Rn-P1), two notable increases values were noticed at distances of 60m and 145m from the start point of the ERT-P1 section. The first small radon peak was found to be directly correlated with a higher permeability structure due to the presence of subsurface fractured zones close to the left edge of the main valley. The second anomalous soil radon signature was also recorded above the site of a major fracture, which

was delineated by the ERT-P1 geoelectrical section at the right margin of the main valley (Figure 3). These relatively high radon signals may reveal the existence of possible spatial relationship with the underlying permeable geologic medium that is associated with the expected fractured zones. Further, this finding may indicate the possibility of using soil gas radon technique as a useful tool for tracing unknown subsurface faults. In view of the geological environment of the studied dam, the

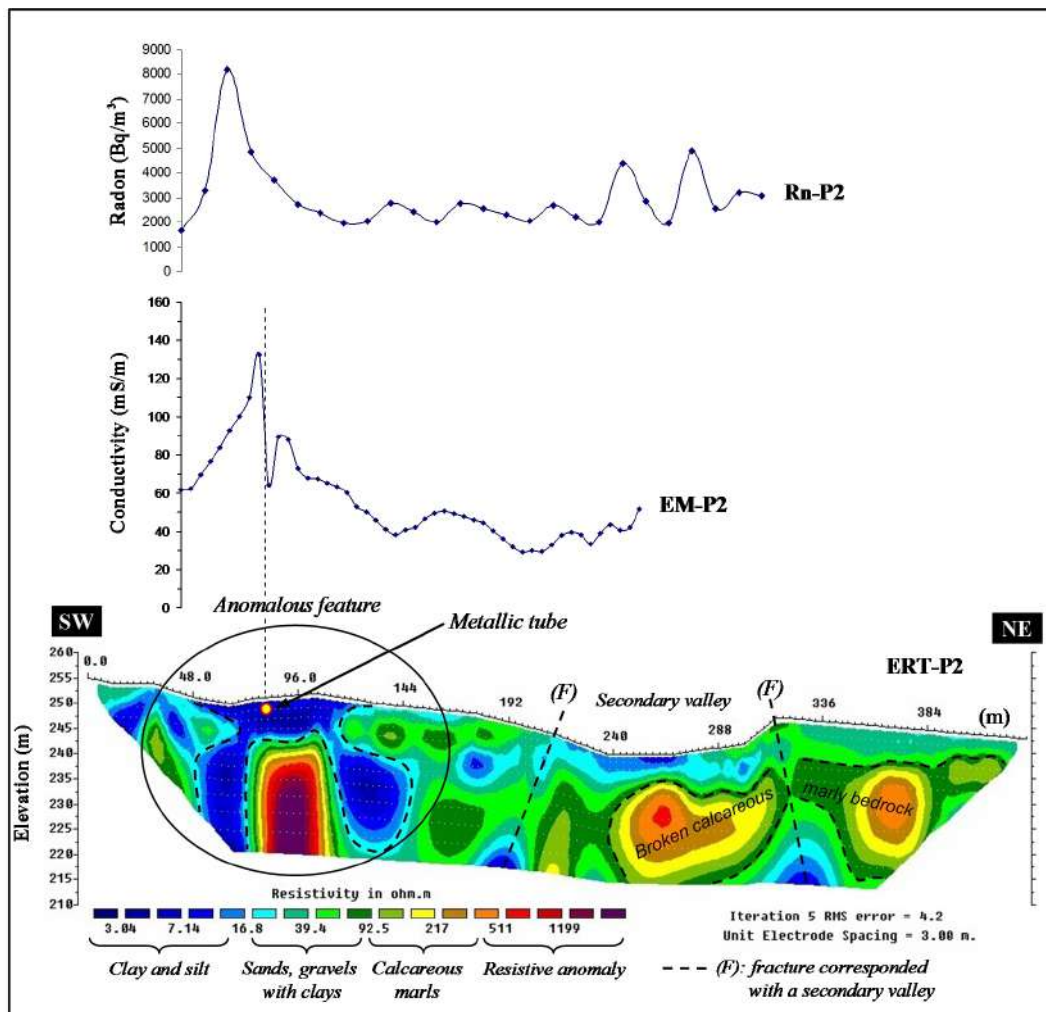
With regard to the ERT-P2 section (Figure 5), it seems to be structural different from the previous ERT-P1 profile because it does not has the same direction locality with respect to the general bedding trends. The most important thing which characterizes the geoelectrical ERT-P2 section is the existence of an abnormal subsurface feature located at the first third of the section. This anomalous feature has a special geometric shape and

located at a depth of 10m from the surface with downward extension. The real nature of this structure did not precisely determined and it could be related to compact massive rocks or archeological remains such as road or tunnel. Thus, more geophysical and archeological investigations are needed to confirm the true nature of this anomaly since the dam's lake is located within the geographic zone of the ancient Roman Afamia city and the site is filled by hundreds of buried Roman graves, wells and others subsurface archaeological monuments. The resistivity of the detected anomalous feature is relatively high and reaches more than 1200Ω.m, whereas it very low and does not exceed 20Ω.m for the clayey deposits that surround the outer edges of the feature. The structural discrepancy between the unknown feature and its surroundings may led to the development of an inhomogeneous

**Figure 5.** Interpretation of the P2 profile which includes the results of ERT, EM and soil radon measurements carried out in Afamia B dam.

situation and could play a negative role in permitting the water to leak down through the cracks that bounded the anomalous object. As the survey proceeds along the same profile (ERT-P2), another clay deposits were observed between the distances 240 and 300m from the start point of the profile. These deposits are lying through a small depression of branch valley that intersects perpendicularly with the linear course of the main valley in the area. However, the field observations indicate that such upright junction is mostly controlled by local tectonics where small fault segments are probably branching out from the main fault associated with the main valley. Moreover, it is clear that the local tectonic setting has led to the break the impermeable hard marl bed coincided with the secondary valley between the distances 210-310m of the ERT section (Figure 5). This finding may enhance in certain way to the occurrence of vertical leakage processes across the secondary valley.

Concerning the EM-P2 measurements, it has been observed that the electrical conductivity values increased notably above the detected anomalous feature reaching  $140\text{mS/m}$  ( $7\Omega\cdot\text{m}$ ). The high conductivity values can be attributed to the accumulation of the clay deposits above the aforesaid abnormal feature. The shifting point which

is observed on the EM curve at a distance of 80m from starting point of the ERT-P1 section is mostly related to the existence of a buried metallic tube at 2m depth, which is connected to the filling tower for air evacuation uses. As the concerned metallic tube is completely surrounded by clayey deposits, thus it cannot be differentiated clearly by the ERT technique because there is no sufficient contrast in the electrical resistivity, while the EM technique is more sensitive and adequate for detecting buried metallic objects (Bevan, 2013; Dionne *et al.*, 2011). On the other hand, a major radon anomaly with a peak value of more than twice higher than the average background level was also recorded at the same locality where the abovementioned subsurface anomalous feature was detected on the ERT-P2 section (Figure 5). This anomalous radon observation is probably related to the surrounding environment of the detected object itself, which may provide an additional driving mechanism that could enhance the upward flow of radon gas through the outer boundary openings and fractures. The detected buried feature seemed to be coated by a thin layer of clay which seems to be shifted downwards through bounding fractures and by the flowing water and re-precipitated underneath the surface along the periphery of the object. Such process indicates mostly vertical discontinuity zones which may possibly

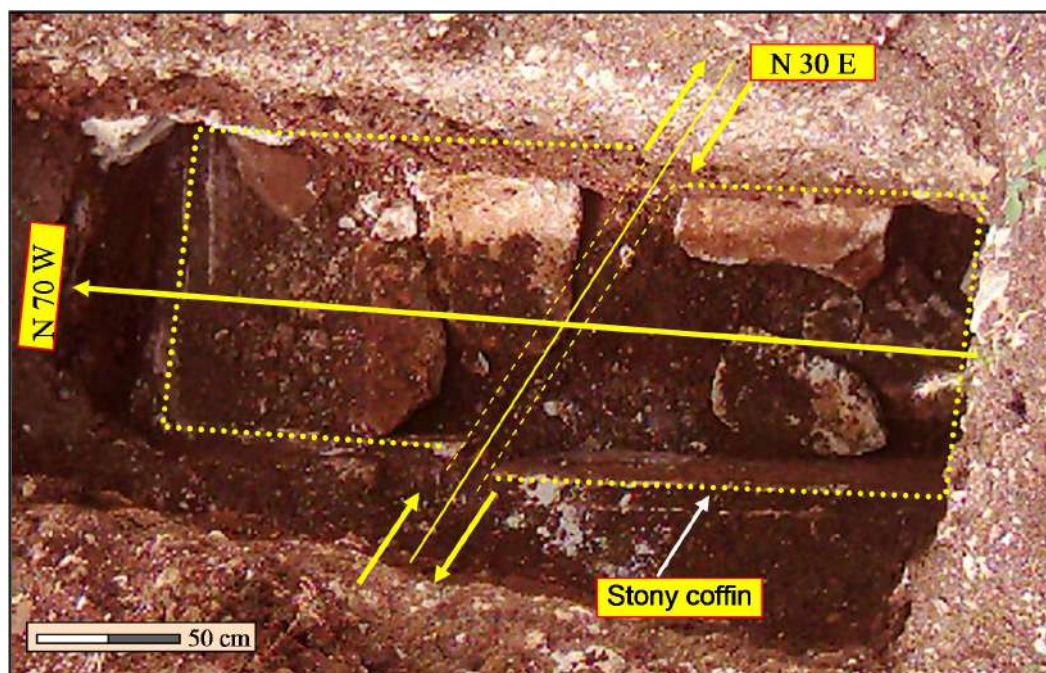
**Figure 6.** A photo of an archeological grave showing a diagonal fracture in a stony coffin found in the Afamia B dam's lake.

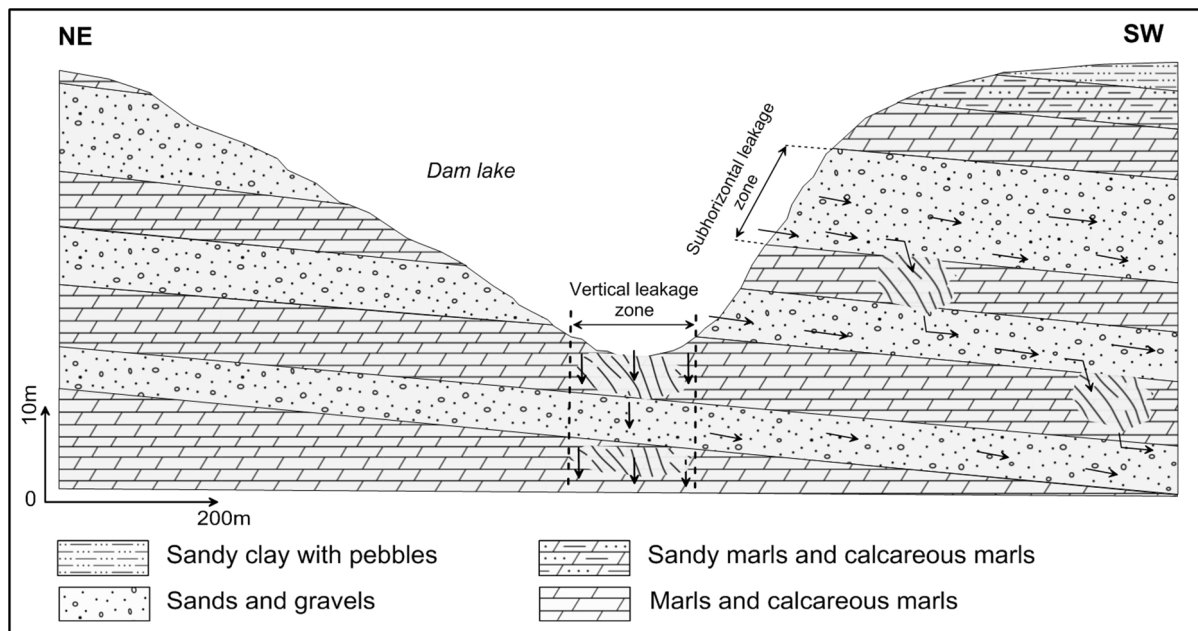
Finally, depending on the results of the geophysical surveys interpretations and some lithological column of boreholes drilled in Afamia dam, a conceptual model was proposed to describe the probable mechanism of water leakage in the dam (Figure 7). Accordingly, two types of leakages can be identified; the first one is a subhorizontal leakage which occurs basically through the permeable layers of sands and gravels. The subhorizontal leakage afterward follows vertical paths in certain locations especially when it meets fractured zones within the calcareous marly beds. The second type of water losses is a vertical leakage, which basically takes place through the base of the main valley and its margins. The marly bedrock which constitutes the bottom of dam's lake seems to be severely eroded and deformed, and thereby it strongly enhances the vertical water leakage processes, which represents the major component of the leakage in the dam.

**Figure 7.** A conceptual model describes the mechanism of the water leakage in Afamia B dam depending on the interpretation of the geophysical and geological data.
