Electrical Resistivity Tomography for the detection of subsurface cavities and related hazards caused by underground coal mining in Coahuila

José A. Batista Rodríguez*, Marco A. Pérez Flores, Yuri Almaguer Carmenates and Maximiliano Bautista Hernández

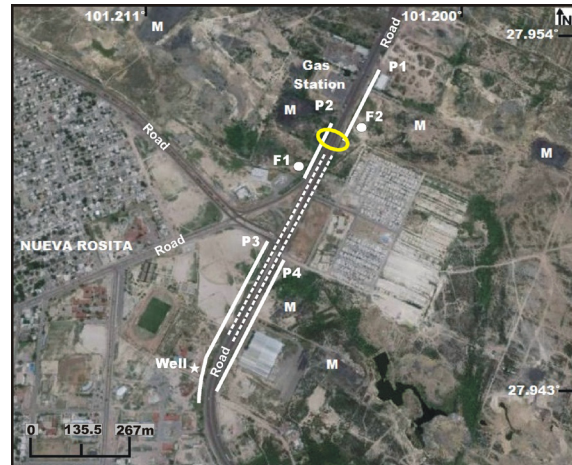
Figure 5. Study Sector 1. M indicates mining zones. Continuous black lines indicate location of the measurement profile (P1, P2, P3 and P4). Dashed black lines indicate location of the bridge. F1 and F2 indicate the reference point for the photographs shown in figures 9b and 9c. Yellow ellipse indicates a subsidence zone on the road (view photography in Figure 9a). Star indicates well.

This sector contains both a road and a bridge support (Figure 5), with subsidence found on the road at the northeast end (Figure 9a), which could be related to the underground coal mining (Peng, 2008) due the shallower mining activities in this sector and its surroundings.

In order to locate and characterize the subsidence-related hazard zones, four ERT profiles (referred as P1, P2, P3 and P4) measured on both sides of the road and at the beginning of the bridge support (Figure 5). The profiles ran on a NE-SW direction of the sector, covering the areas of the road affected by subsidence (profiles 1 and 2, with lengths of 270 m) and other areas where this geological process is not observed (profiles 3 and 4). Conglomerates were found to outcrop in the four profiles (Figures 1, 10 and 11).

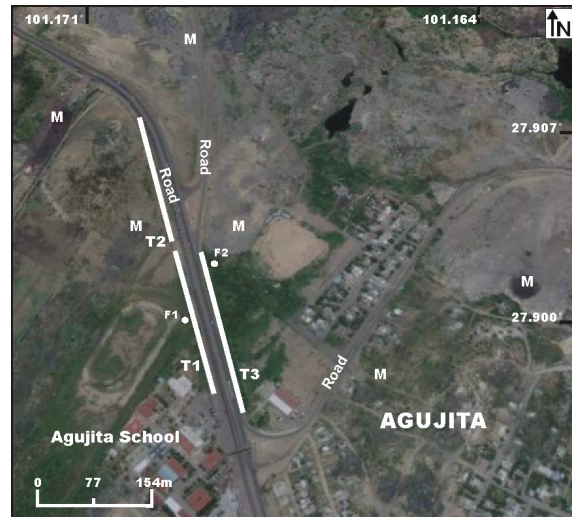
Figure 6. Study Sector 2. Continuous white lines indicate location of the measurement profile (T1, T2 and T3). F1 and F2 indicate the reference point for the photographs shown in figures 13a and 13b.

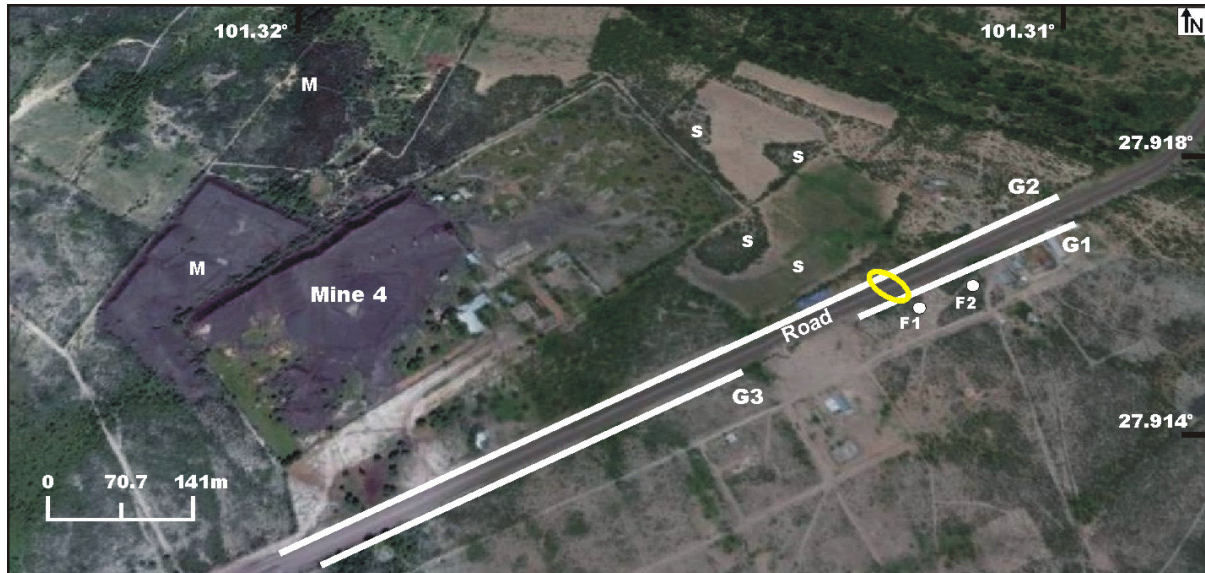
Figure 7. Study Sector 3. Continuous white lines indicate location of the measurement profile (G1, G2 and G3). S indicates areas with a sinkhole. F1 and F2 indicate the reference point for the photographs shown in figures 14c and 14d. Yellow ellipse indicates a subsidence zone on the road (view photography in Figure 14a).

An overlap on the data profiles was created between the lines in P2 on Sector 3 (Figure 7) in order to ensure the continuity of the model and attain a length greater than 540 m. This overlap was achieved using the Roll-along technique, in which the electrode cable advance forward along the measurements profile by moving your cable sections in a leap-frog way. Subsequently, the joint inversion of the three arrays was performed using EarthImager 2D resistivity inversion software developed by Advanced Geosciences, Inc. The software uses a finite element algorithm to compute the estimated real resistivity (model) thought the apparent resistivity data (AGI, 2009), from which a geological explanation for every 2D resistivity model was found (Huebner and Thornton, 1995). The geophysical inversion gives us the resistivity model with a very low or the lowest Root Mean Square (RMS) error value, according the imposed inversion parameters. This RMS error quantifies the difference between the apparent resistivity measured in the field and the apparent resistivity obtained from the response of the 2D resistivity model estimated. In this way, a single resistivity model was obtained for every profile with three datasets (schlumberger, wenner and dipole-dipole).
