# Neotectonic related geological risk at dams in the Mexico Basin: Guadalupe dam

Salvador Marín-Córdova<sup>1</sup>, Oscar Campos-Enríquez<sup>2</sup> and Mario Herrera-Moro-Castillo<sup>3</sup>

## ABSTRACT

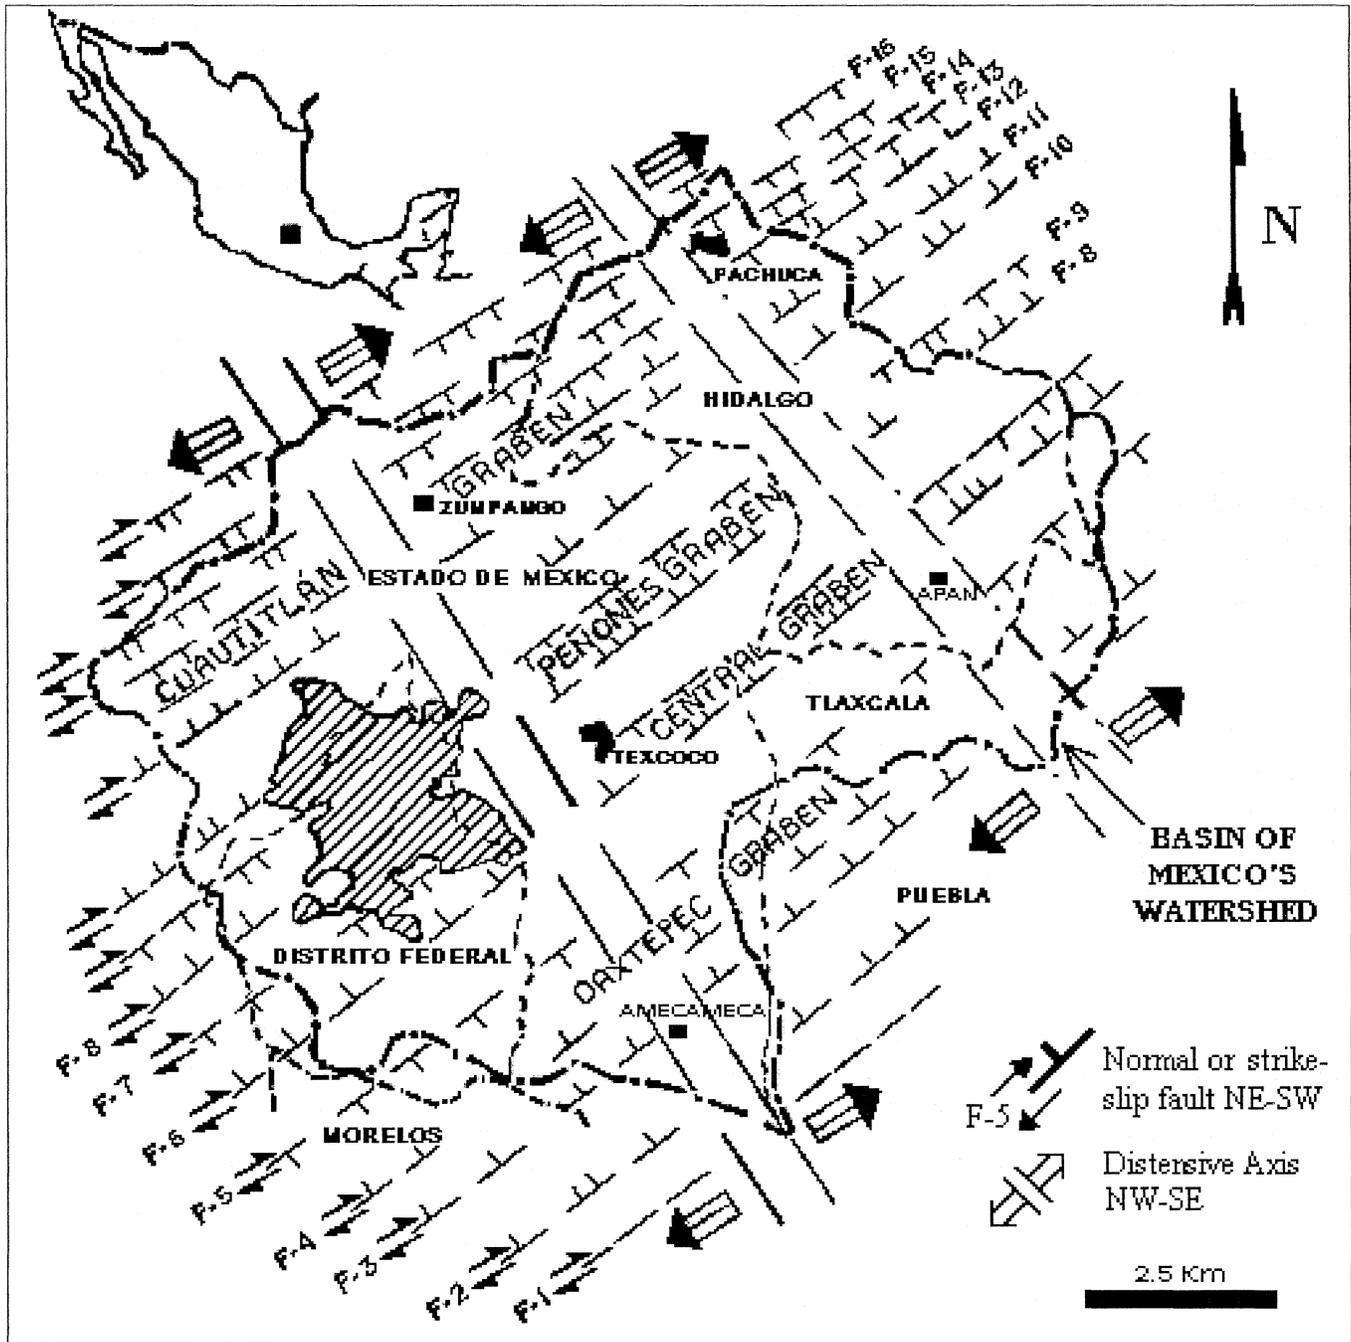
The analysis and correlation of all this information enables us to propose a geological and structural framework for the Mexico Basin and surrounding areas (Figure 1), where sixteen main faults are illustrated and which delimit fifteen blocks.

Fig. 1. Location of sixteen faults within the Mexico Basin after Marín-Córdova *et al.* (1986 b).

As shown in Figure 1, the main normal or strike-slip faults crossing the southwestern portion of Mexico Basin are located between the F-7 and the F-14 faults. Many of them coincide with river beds that drain the zone. These features are summarized here:

Guadalupe Dam was considered here for geologic risk, because there are extensive operation reports, where settlements and cracks are described. It was built on Cuautitlán river that, according to the geological – structural studies, is located on one of the main fault alignments (F-12). It had not been considered because it was unknown at construction time (Figure 2).

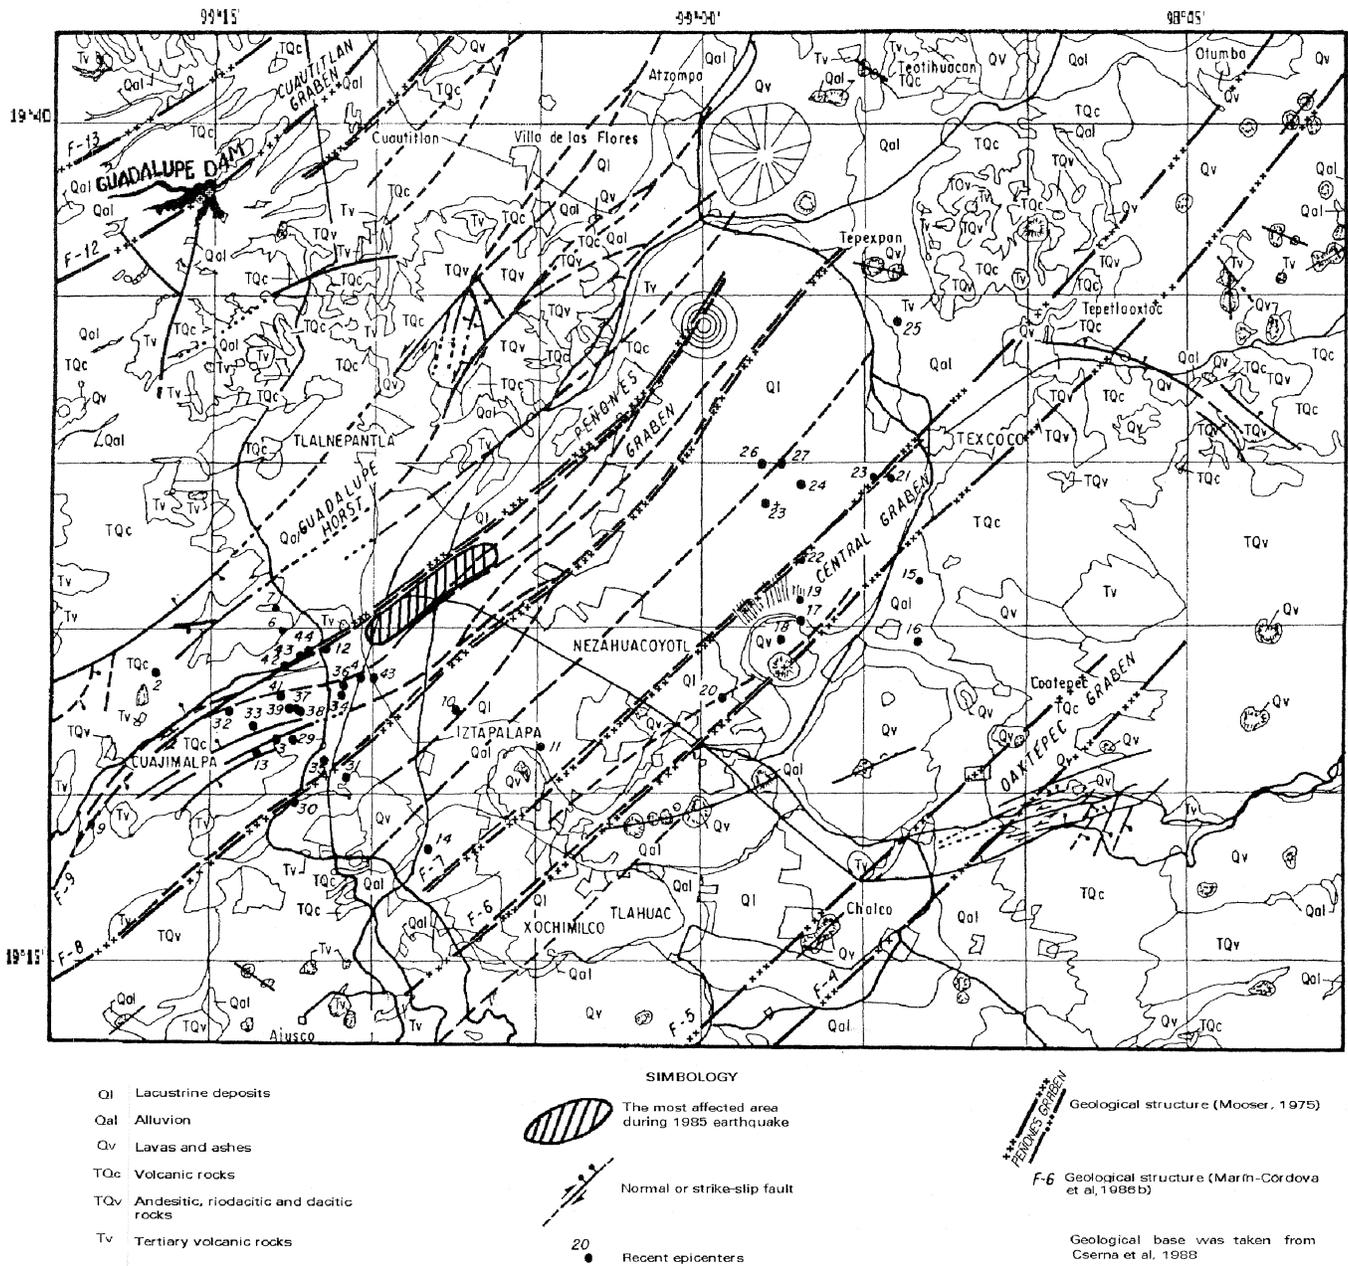
Thus three structural models are similar in the main. They differ in coverage of the basin and in the objective of the study. These three studies are synthesized in Figure 2.

Fig. 2. Schematic map with structural intergrated models after De Cserna *et al.* (1988).
