APPLICATION OF QUANTITATIVE ELECTROMAGNETIC TECHNOLOGY TO ASSESS COATING INTEGRITY OF PIPELINES IN MEXICO

Omar Delgado-Rodríguez^{1*}, Aleksandr Mousatov², Edgar Kiyoshi Nakamura-Labastida² and Vladimir Shevchin³

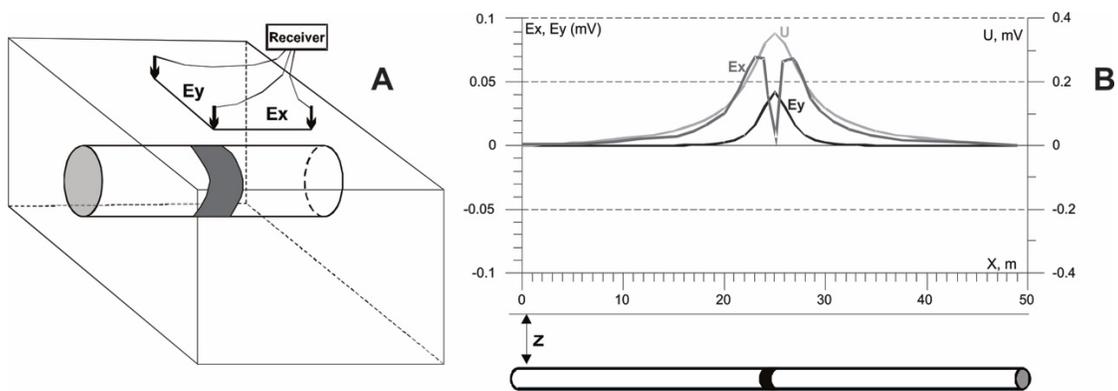
Figure 1. Electric field anomalies. A) Type "L" electrode array to measure the two horizontal components of the electric field on the pipe. B) Graphs of electric and potential field on pipeline with damaged coating at point 25 m. Z is equal to 1.5 m.

Now, if we consider a type "L" electrode array with a separation between electrodes of 1 m, is placed on pipeline to obtain the electric measurements (Figure 1A) and the step between measurement points along the pipe axis is 1 m, the anomaly magnitudes E_x and E_y depend on the leakage current (I_l), pipe depth (Z), and ρ_s values (see equations (4) and (5)). The measurements obtained are plotted in Figure 1B. The E_y anomaly is as simple as the U anomaly, while the E_x anomaly has two peaks separated by a minimum indicating the location of the source (Figure 1B). Due to this, in order to obtain the electric measurements in the local stage, only E_y will be measured using an electric dipole oriented perpendicular to the pipe (E_y), placing one electrode above the pipeline.

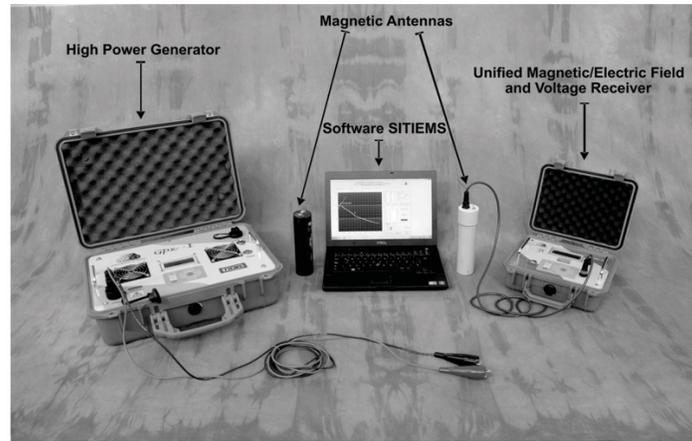
Figure 2. High power generator, unified magnetic-field, electric-field and potentials receiver, magnetic antennas and SITIEMS software.

We have developed electromagnetic instruments to properly evaluate the insulation coating. The SEMPI instrumentation includes: a high power generator, a unified receiver for measurements of the magnetic-field, electric-field and voltage, induction antennas as magnetic field sensors and the SITTEMS software for processing and interpreting experimental data (Figure 2).

The equipment developed is robust and able to work in different geographical and weather conditions. The high-power generator, high-resolution receiver and high-sensitivity antennas (Figure 2, Table 1), allow for the recording of reliable field data in pipeline routes under complex conditions (nearby pipelines and resistive subsoil).

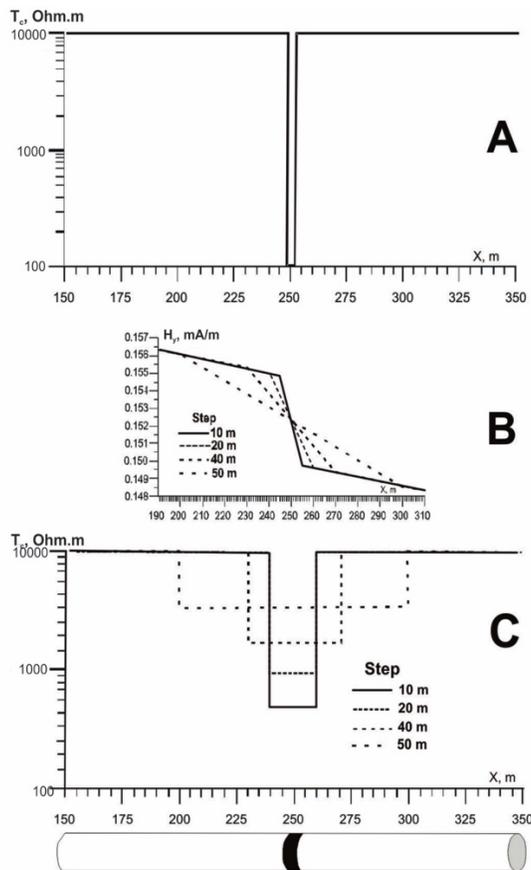
Figure 3. A) Model of pipe with damaged coating at interval 249 to 251 m, with coating resistance (T_c) values of damaged coating = 100 Ohm.m and coating in good condition, $T_c = 10,000$ Ohm.m. B) Magnetic field measured for different measurement intervals.

The holiday or disbondment area is often a small part of the pipeline surface through a significant magnitude of current leaks to the soil. High resolution is required to find these small damages. To study the resolution in determining coating damage, we analyzed the distributions of the magnetic field along the pipe as a function of the distance between the measurement points. Figure 3A shows a pipe with severe damage in the coating in the interval 249 m to 251 m ($T_{c2} = 100$ Ohm.m). In the intervals $0 \leq x < 249$ m and $251 < x \leq 500$ m, the coating quality is perfect ($T_{c1} = T_{c3} = 10,000$ Ohm.m). The model includes the following metal pipe parameters: conductivity $\sigma = 10^7$ Ohm/m, OD = 0.2 m, wall thickness $\Delta r = 0.01$ m. The AC generator (625 Hz) is connected to the starting point of the pipeline ($x = 0$ m). The proposed distances between measurement points along the pipeline were: 10, 20, 40 and 50 m.

Figure 3B shows the behavior of the magnetic field (H_y) obtained for different lengths of the measuring step. The resolution of the technique depends on the measurement interval of the magnetic field. When the measuring step increases the resolution in the localization (Figure 3B) and quantification (Figure 3C) of the damaged coating decreases. For example, for the 10 m and 20 m steps, the leakage current anomaly shows damaged coating in a pipeline section length 20 m (medium resolution), with $T_c = 650$ Ohm.m, considerably less than 10,000 Ohm.m; the 50 m step locates a longer pipeline section (low resolution) with a T_c value (5,000 Ohm.m), which is less anomalous than those determined for shorter measurement steps. However, even for large measurement steps (e.g. 50 m), the leakage current through the damaged coating is expressed by a fall in the magnitude of H_y . This feature provides the implementation of magnetic field measurements that are more productive and efficient than electrical measurements (DCVG or ACVG methods), which require measurements at short steps (e.g. 1 m) to detect the current leakage caused by the damaged coating.

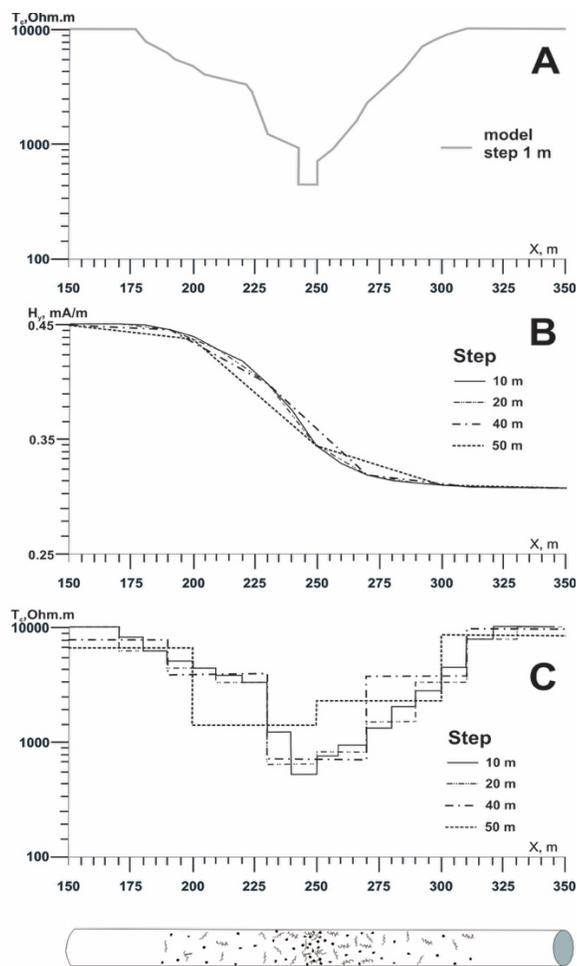
Figure 4. A) Model of pipe with irregular deteriorating (pores and fractures) of coating in the 175 m - 310 m pipe section, and coating in good condition ($T_c = 10,000$ Ohm.m) in the 150 m – 175 m and 310 m – 350 m sections. B) Magnetic field measured for different measurement intervals. C) Coating resistance recalculated from different measurement steps.

Figure 4 shows a section of pipeline with coating damaged by pores and fractures distributed in the interval 175 m to 310 m, reaching the minimal values of $T_c = 650$ Ohm.m in the interval $240 \text{ m} < x \leq 250 \text{ m}$. In the intervals $150 \leq x < 175 \text{ m}$, and $310 < x \leq 350 \text{ m}$ the coating quality is perfect ($T_c = 10,000$ Ohm.m). The pipe model (Figure 4A) includes the same pipeline parameters as those used in the model for Figure 1, as well as the measurement steps (Figures 4B and 4C). Following the example of Figure 4, we have falls in the H_y field in all measuring steps, whereas each T_c graph (Figure 4B) shows different resolution levels according to the measuring step. The T_c graph for the 10 m step (Figure 4B) is similar to the pipe model (Figure 4A).

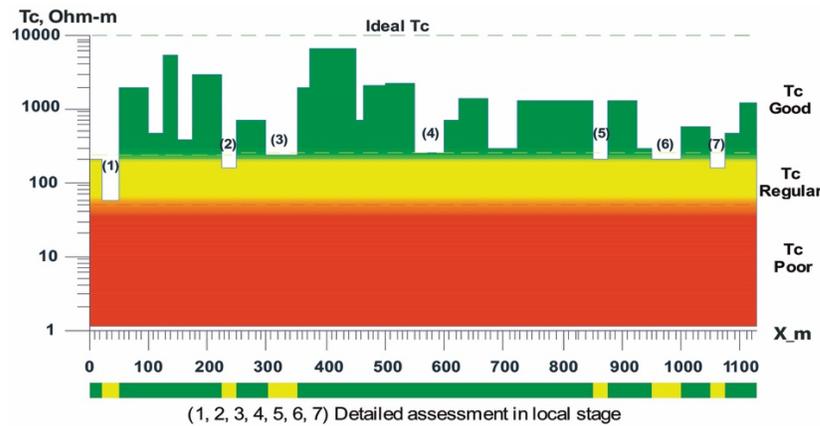
Figure 5. Coating resistance (T_c) graph, indicating zones with regular quality coating.

Figure 5 shows the T_c graph for the inspected pipeline, confirming that SEMPI is able to not only to locate, but also adequately quantify coating damages. Based on the results shown in Figure 5, some representative points of the condition of pipeline coating (green, yellow and red zones) were selected to carry out detailed electric measurements for precise localization and quantification of the damages in the coating.

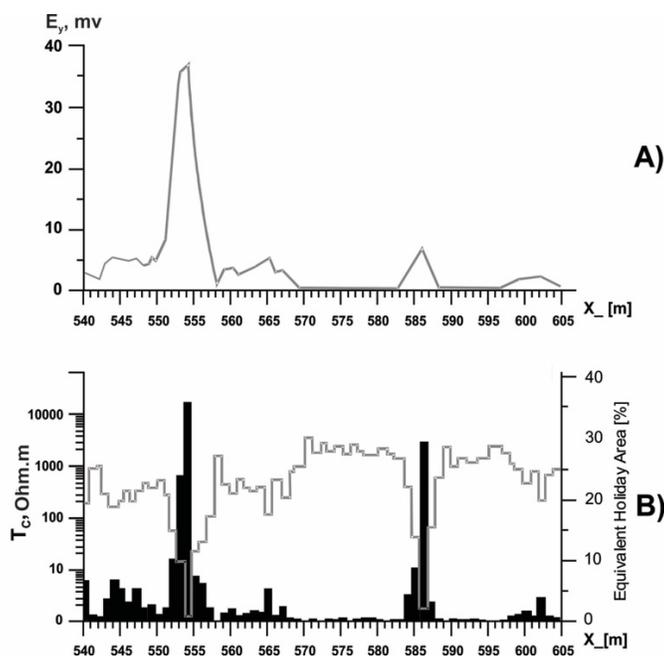
Figure 6. Results obtained from local stage of SEMPI applied in the anomalous pipeline interval 540 m - 605 m determined in the regional stage (see Figure 4). A) Electric field measurements. B) Detailed T_c values and EHA percentage.

Figure 6 shows the results achieved from the application of the local stage in the anomalous area (4) (pipe interval 540 m – 605 m, see Figure 5), where electric field measurements were performed at interval of 1 m (Figure 6A). The experimental data of the electric field are used in an inversion process by taking into account voltage, soil resistivity and pipe depth values, resulting in the fitting of the theoretical and experimental curves and the determination of the T_c and EHA (%) values for each lineal meter of the pipeline (Figure 6B). Two minimum values of T_c are determined at points 554 m and 586 m, reaching EHA values of 35% and 29%, respectively.

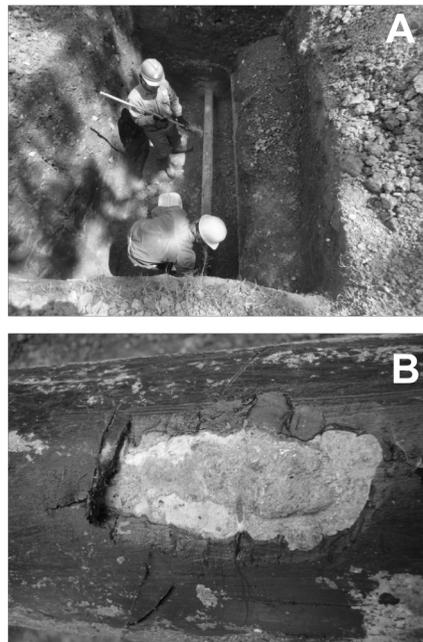
Figure 7. Verifying the main anomalies detected and quantified by SEMPI technology. A) Excavation performed in the pipeline interval 540 m – 605 m. B) Zoomed view of the coating damage located at point 554 m.

Subsequent excavations were carried out at every (1 to 7) anomalous interval determined in the regional stage of SEMPI. Figure 7A shows the 1.5 m x 2.5 m excavation carried out at the pipe anomalous interval 4 (see Figure 5), which confirms the existence of severe damage (holiday) to the insulation coating at point 554 m (Figure 7B) causing a major leakage current from the cathodic protection (CP) system and, consequently, corrosion processes. This result confirms that SEMPI is able, not only to locate, but also to adequately quantify coating damage.

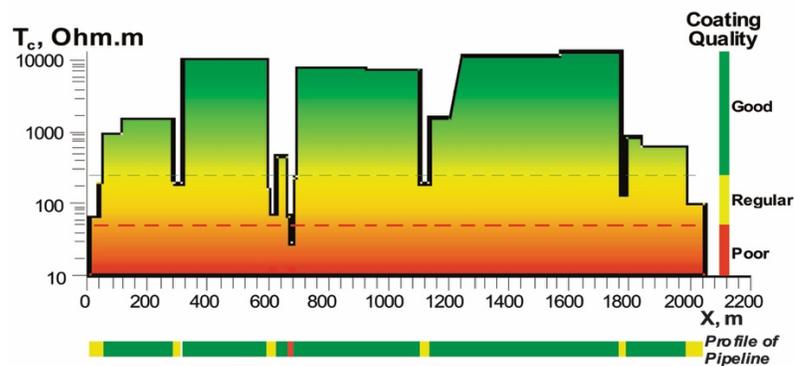
Figure 8. Coating resistance (T_c) for the 4 in OD gas pipeline. T_c graph indicate a zone with poor quality coating at interval 670 m - 700 m. Plan view of the pipeline with the T_c color scale is presented below the T_c graph.

In order to evaluate the coating quality of a 4 in OD gas pipeline of 2.4 km length, the local and regional stages of the SEMPI were performed. Through the application of the regional stage the T_c values obtained (Figure 8) show an overall good condition of the coating with a mean value of $T_c = 2,438$ Ohm.m (Figure 8), reaching in some pipe intervals the ideal value of 10,000 Ohm.m. In some small intervals there are low T_c anomalies. Most T_c anomalies indicate moderate damage to the coating (yellow zone, Figure 8). However, the pipeline interval 670 m - 700 m presents severe damage in the coating (red zone, $T_c = 30$ Ohm.m, Figure 8). This critical pipeline interval must be inspected at high resolution through the application of the local stage of the SEMPI.

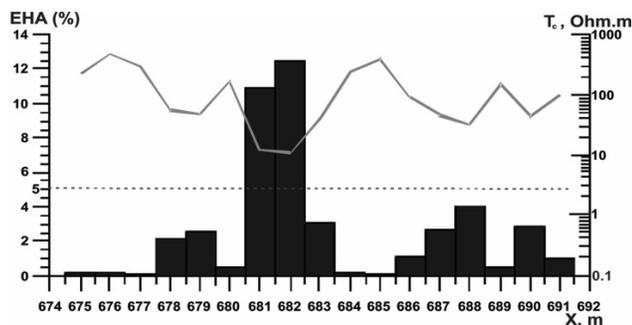
Figure 9. EHA and T_c values, for the anomalous 4 in OD gas pipeline interval 674 m - 692 m, determined in the local stage.

Figure 9 shows the detailed behavior of T_c , observing a minimum of 10 Ohm.m in the interval X = 681-682 m. The EHA reaches a maximum of 13% at X = 682 m, as a point where pipeline has critical damage to the coating. At the point X = 682 m an excavation (Figure 10A) was conducted which confirms the existence of physical contact between the 4 in OD gas pipeline and the 10 in OD oil pipeline (Figure 10B). This physical-electrical contact between pipes produces a major leakage current from the CP system and, consequently, corrosion processes.

We recommended repairing the pipeline coating at the point X = 682 m and the installation of devices to electrically isolate both pipes, thus optimizing the CP system of the 4 in OD gas pipeline.

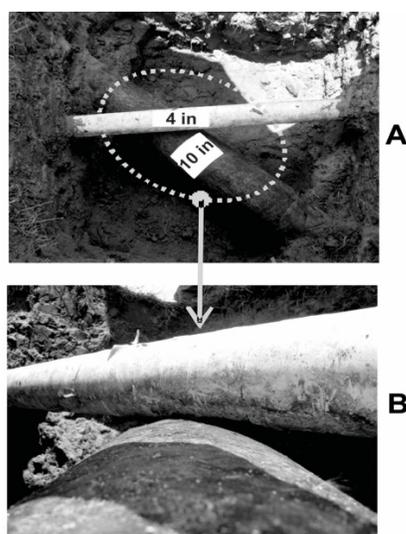
Figure 10. Excavation at X = 682 m of 4 in OD gas pipeline. A) Plan view of the excavation with pipelines crossing. B) Zoomed view of the contact between pipes that causes damage in the coating.
